# Photographic Record Cascade Mine Drainage

DSL-AMRB 91-001

Near Towns of Centerville, Stockett and Belt  
Cascade County, Montana

December, 1992  
Robert Peccia & Associates

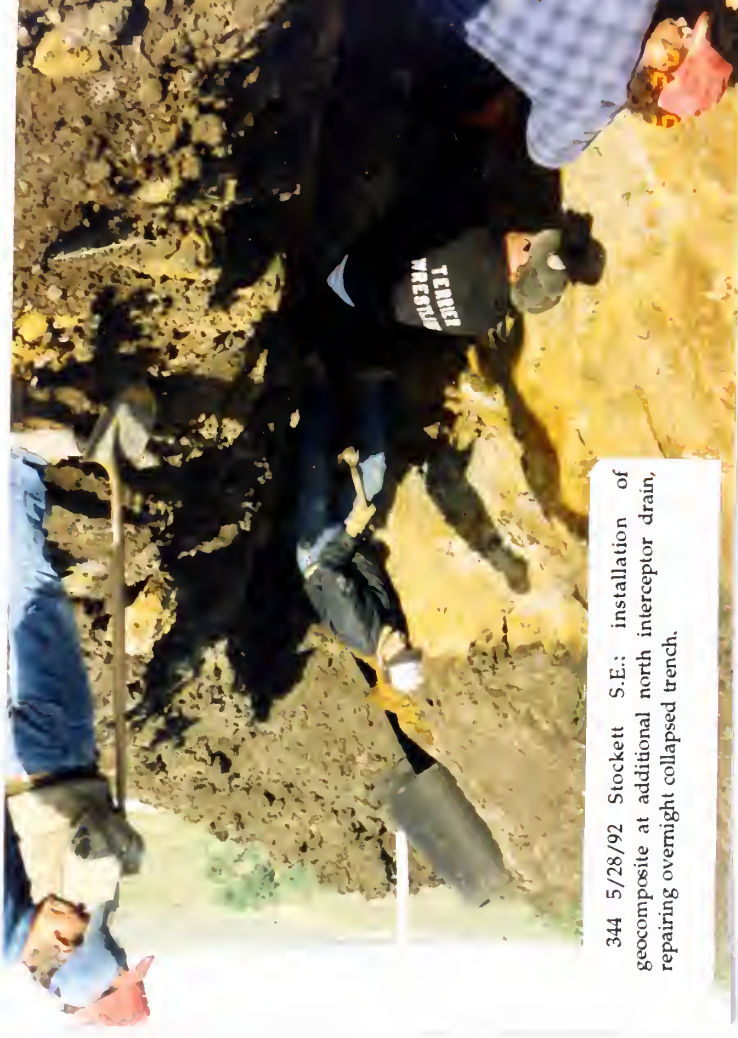
344 5/28/92 Stockett S.E.: installation of geocomposite at additional north interceptor drain, repairing overnight collapsed trench.

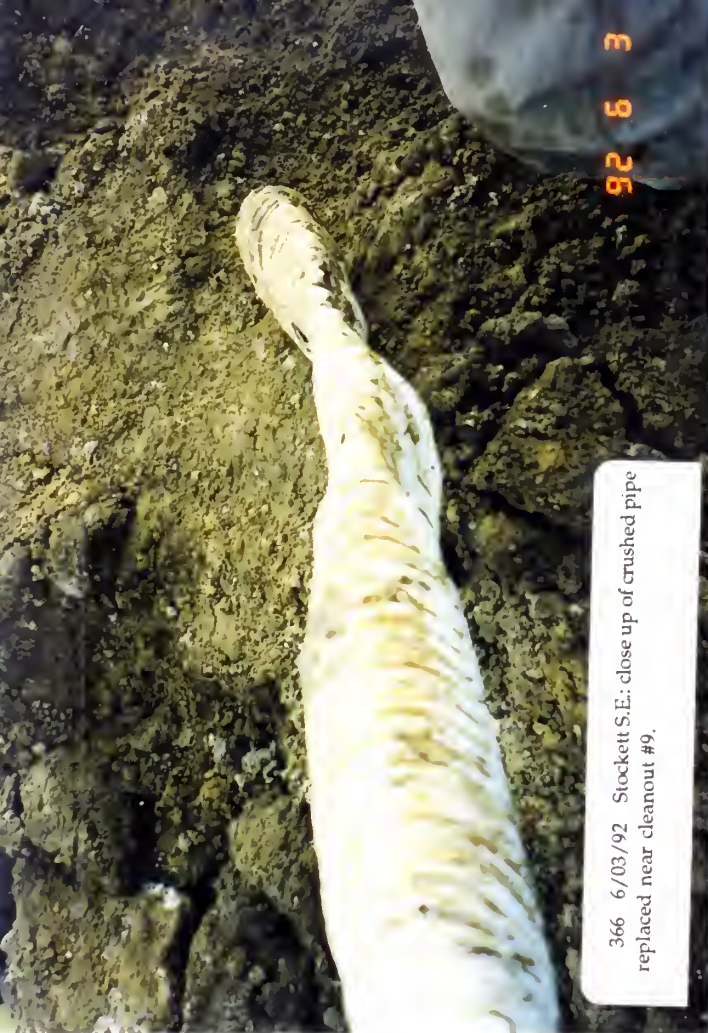
365 6/03/92 Stockett S.E.: close up of crushed pipe replaced near cleanout #9.

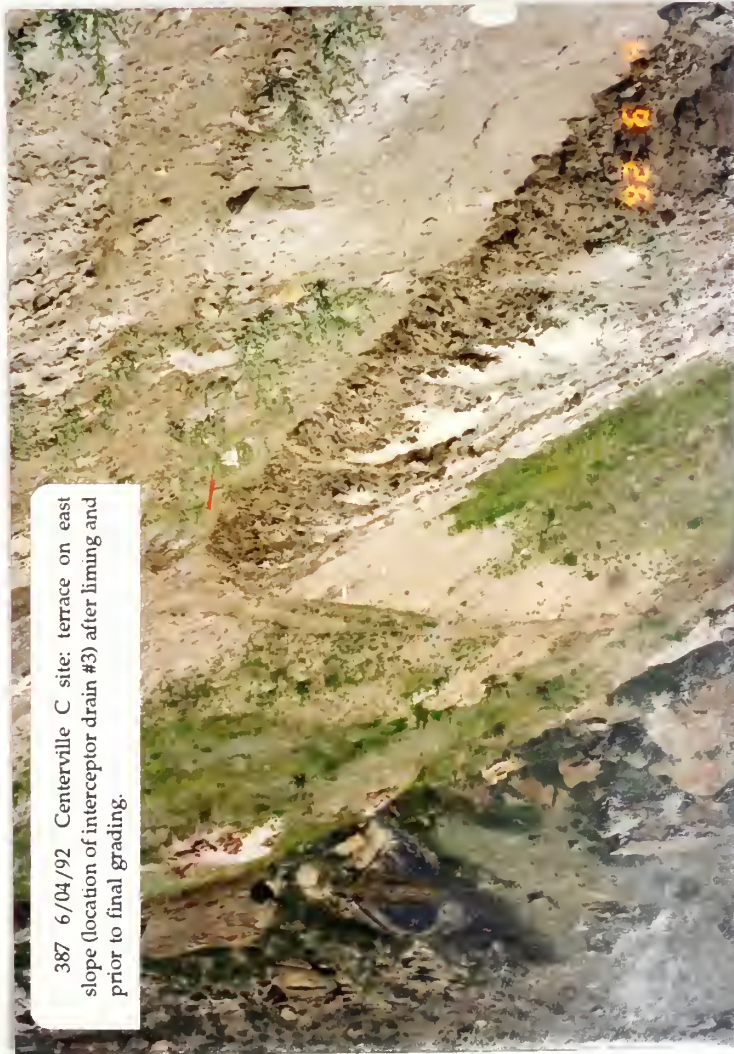
388 6/08/92 Centerville C site: cattails in cell 3 (planted 5/01/92) showing poor cattail growth compared to cell 1.

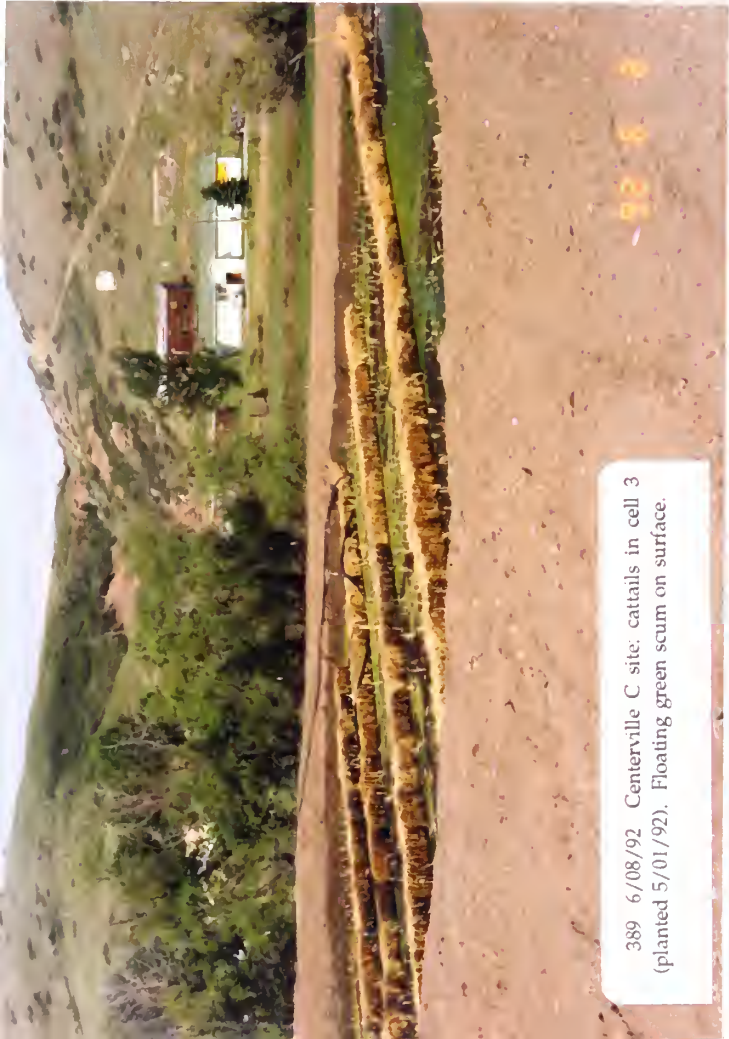
389 6/08/92 Centerville C site: cattails in cell 3 (planted 5/01/92). Floating green scum on surface.

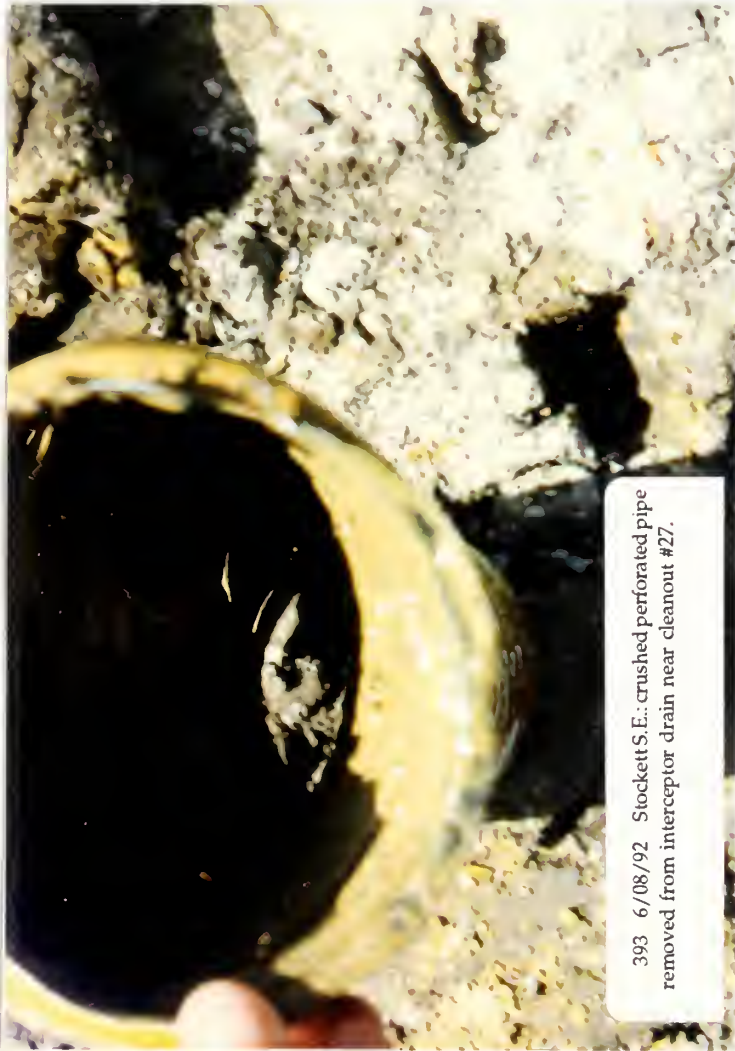
393 6/08/92 Stockett S.E.: crushed perforated pipe removed from interceptor drain near cleanout #27.

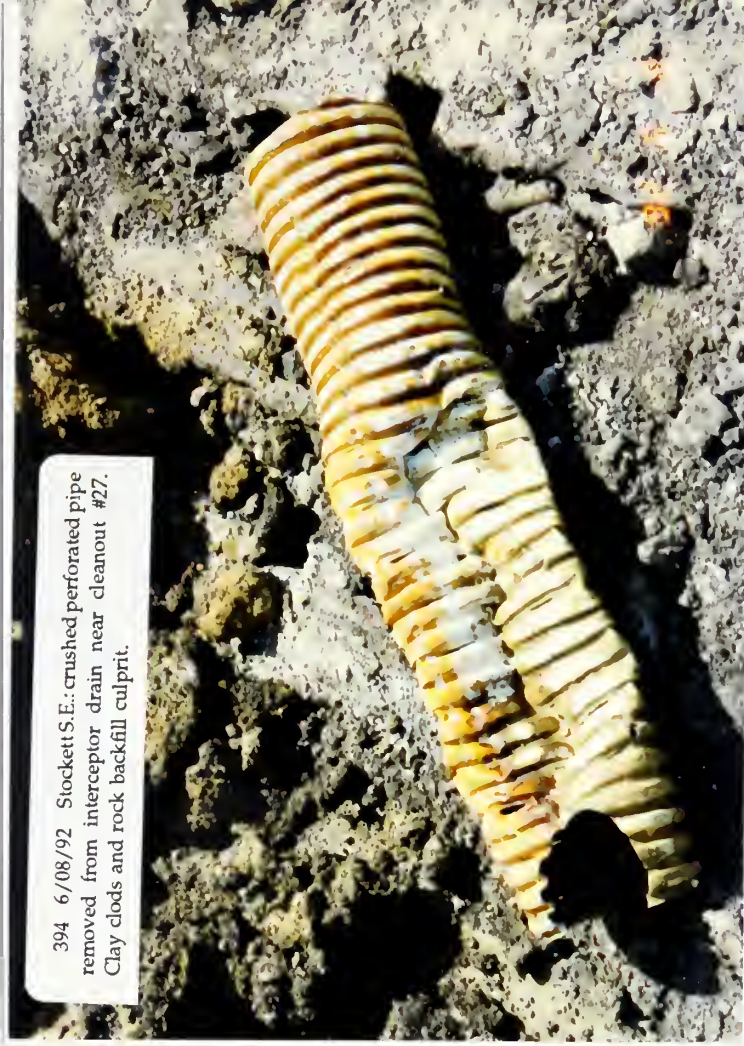
394 6/08/92 Stockett S.E.: crushed perforated pipe removed from interceptor drain near cleanout #27. Clay clods and rock backfill culprit.

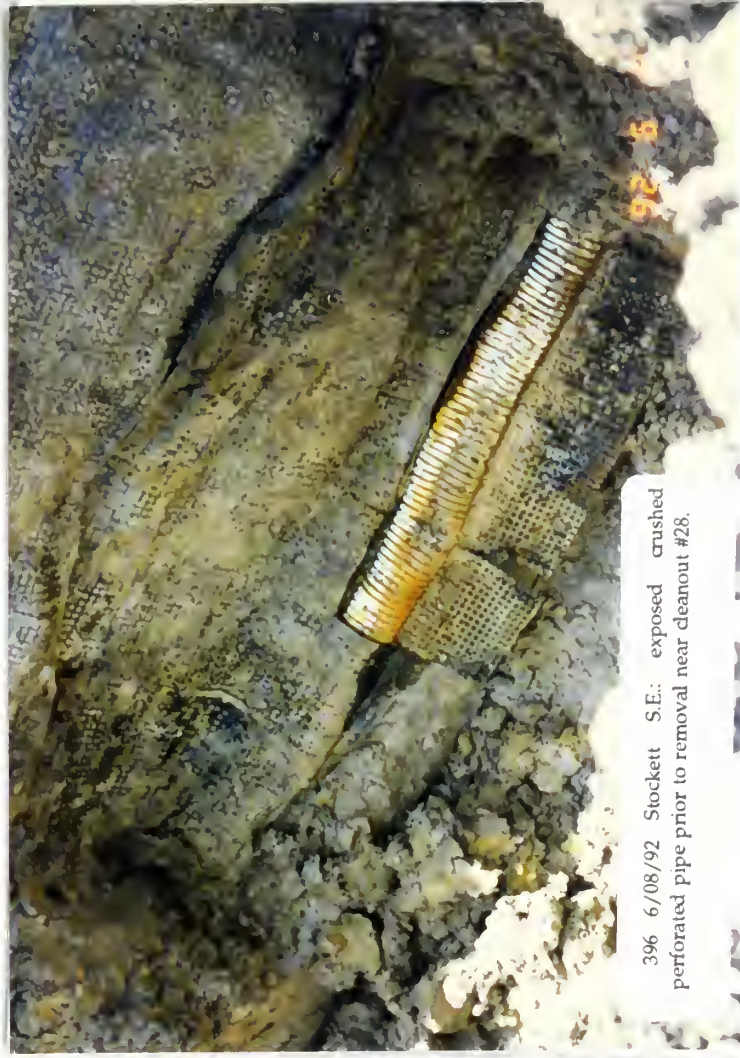
396 6/08/92 Stockett S.E.: exposed crushed perforated pipe prior to removal near cleanout #28.

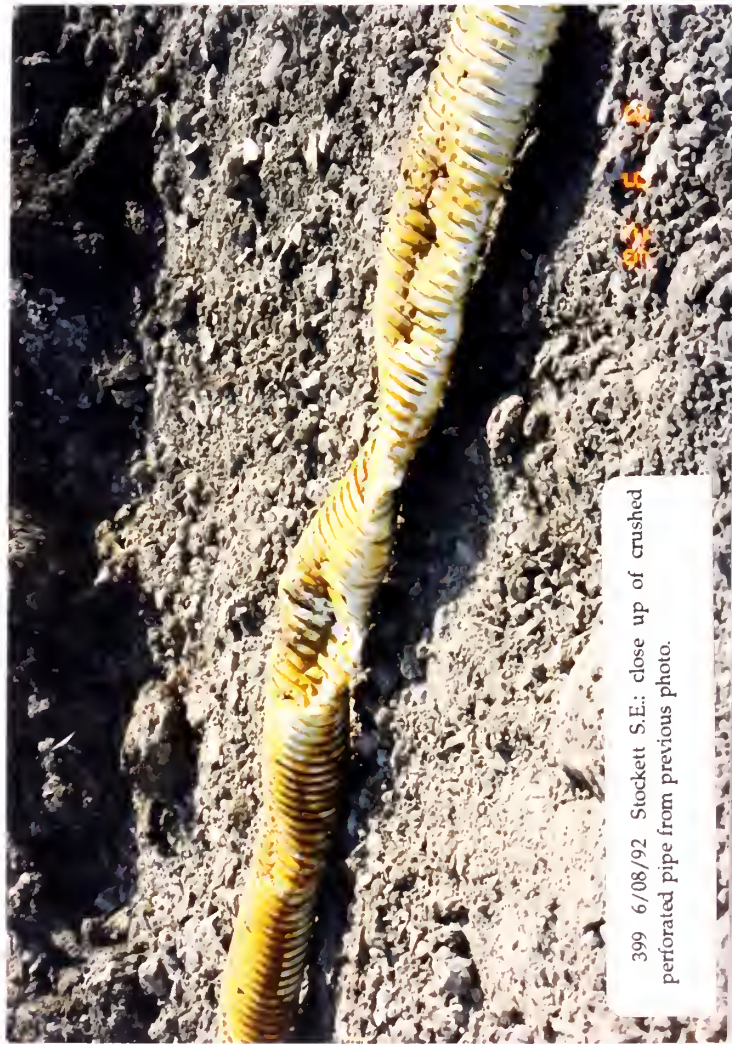
399 6/08/92 Stockett S.E.: close up of crushed perforated pipe from previous photo.

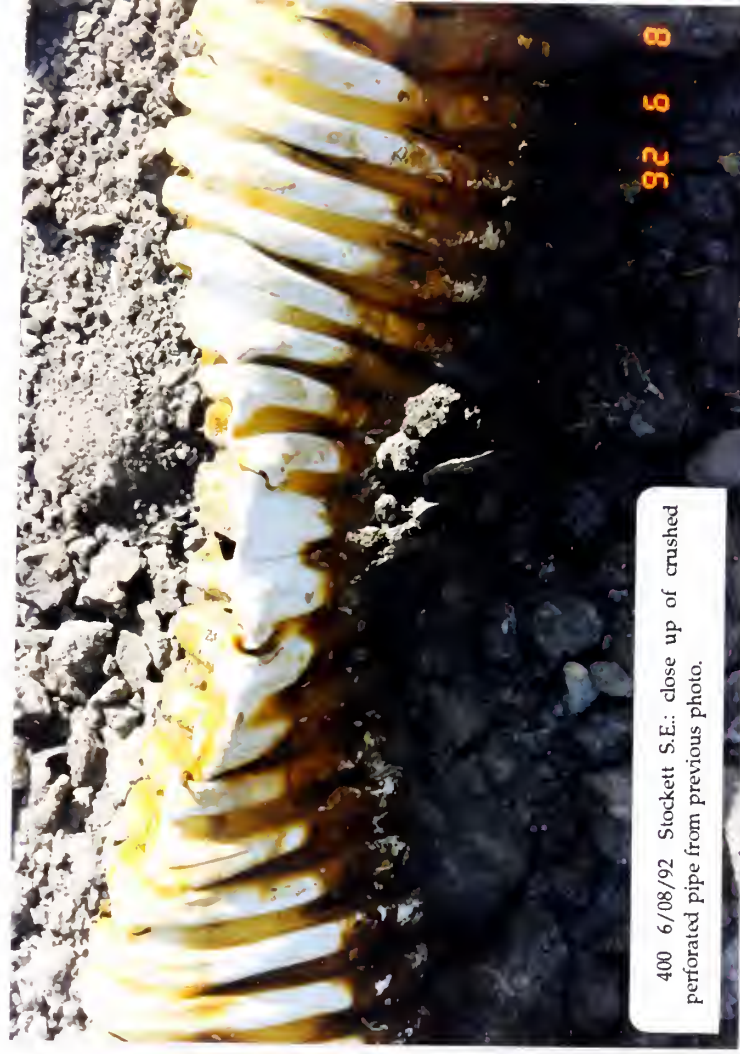
400 6/08/92 Stockett S.E.: close up of crushed perforated pipe from previous photo.

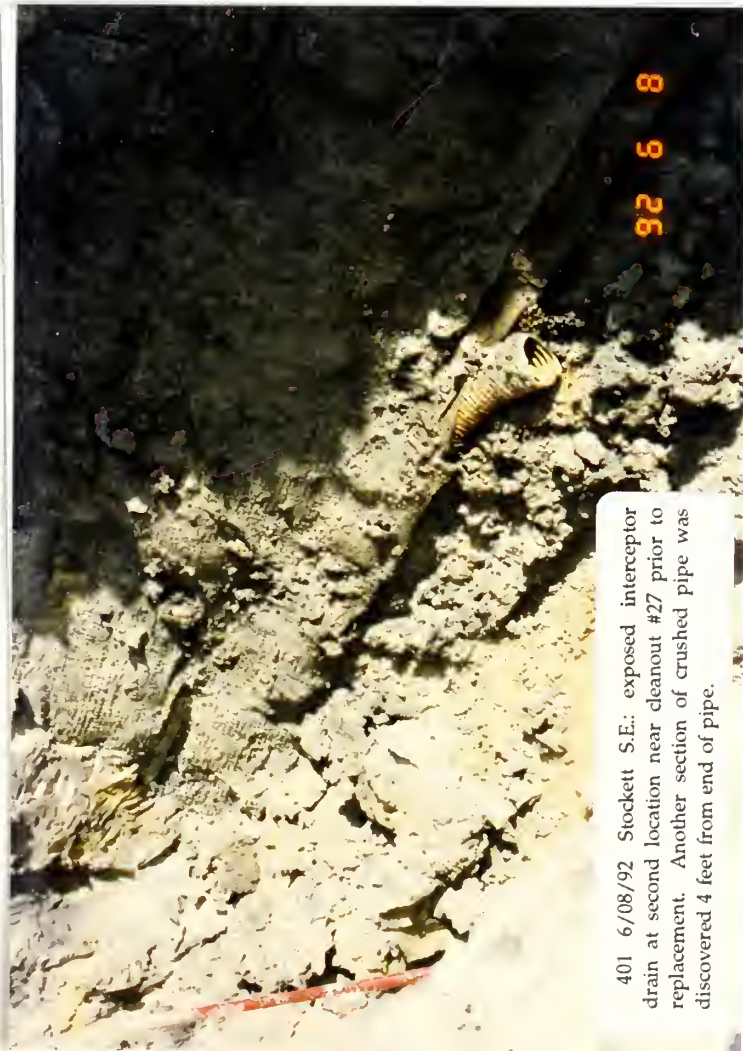
<u>Number</u>	<u>Date</u>	<u>Site Name</u>	<u>Description</u>
401	6/08/92	Stockett S.E.:	exposed interceptor drain at second location near cleanout #27 prior to replacement. Another section of crushed pipe was discovered 4 feet from end of pipe.
402	6/08/92	Stockett S.E.:	additional crushed perforated pipe near cleanout #27.
403	6/09/92	Stockett S.E.:	total of 11' of crushed perforated pipe removed from near cleanout #27.
404	6/09/92	Stockett S.E.:	geocomposite patch placed around replaced perforated pipe near cleanout #27.
405	6/09/92	Stockett S.E.:	backfill repaired interceptor drain near cleanout #27. Note clay backfill.
406	6/09/92	Stockett S.E.:	excavation to expose crushed perforated pipe near cleanout #26.
407	6/09/92	Stockett S.E.:	replaced 4' section of perforated pipe and geocomposite patch near cleanout #26.
408	6/09/92	Stockett S.E.:	head of sewer tape used to snake perforated pipe to locate pipe blockages.

401 6/08/92 Stockett S.E.: exposed interceptor drain at second location near cleanout #27 prior to replacement. Another section of crushed pipe was discovered 4 feet from end of pipe.

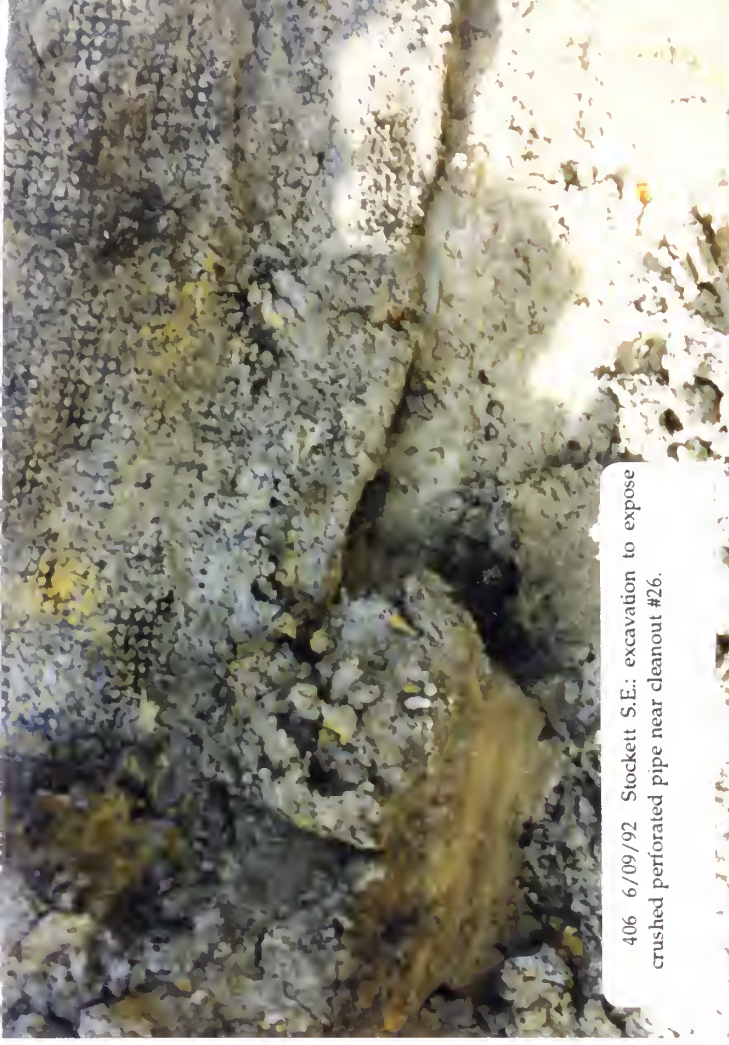
406 6/09/92 Stockett S.E.: excavation to expose crushed perforated pipe near cleanout #26.

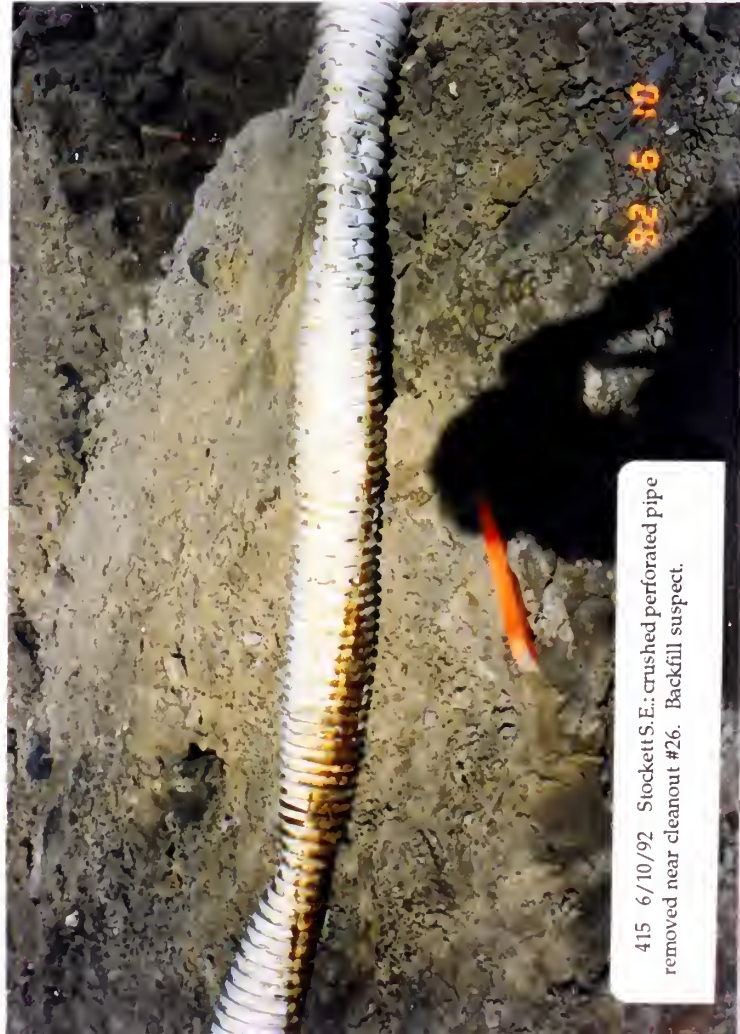
415 6/10/92 Stockett S.E.: crushed perforated pipe removed near cleanout #26. Backfill suspect.

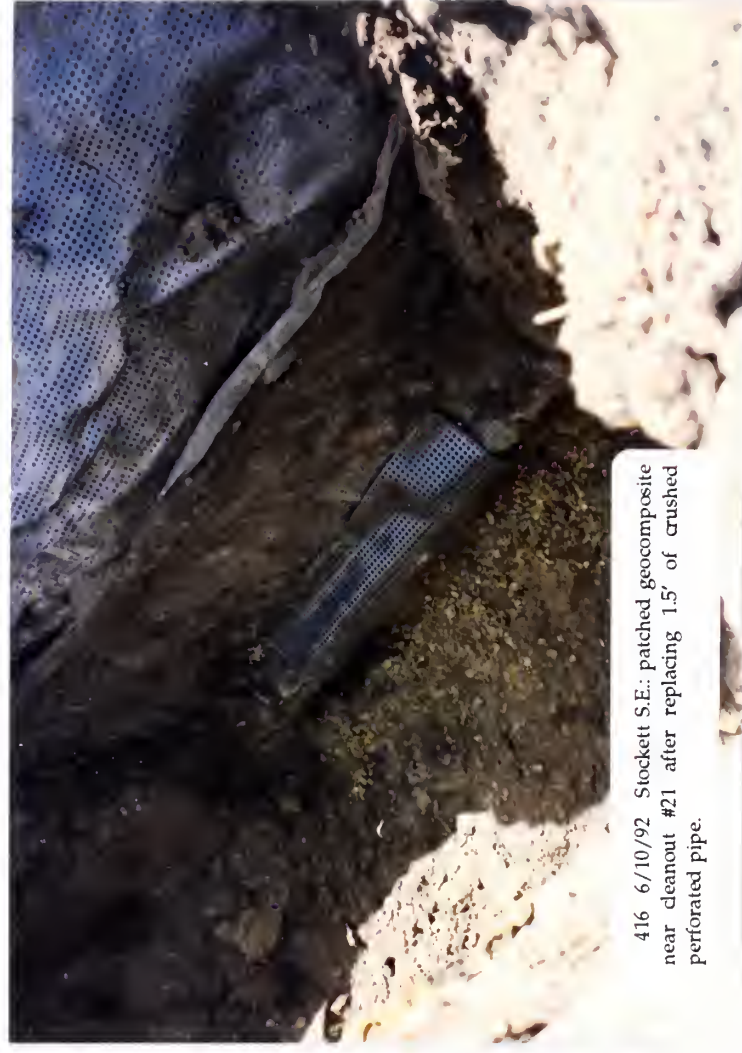
416 6/10/92 Stockett S.E.: patched geocomposite near cleanout #21 after replacing 1.5' of crushed perforated pipe.

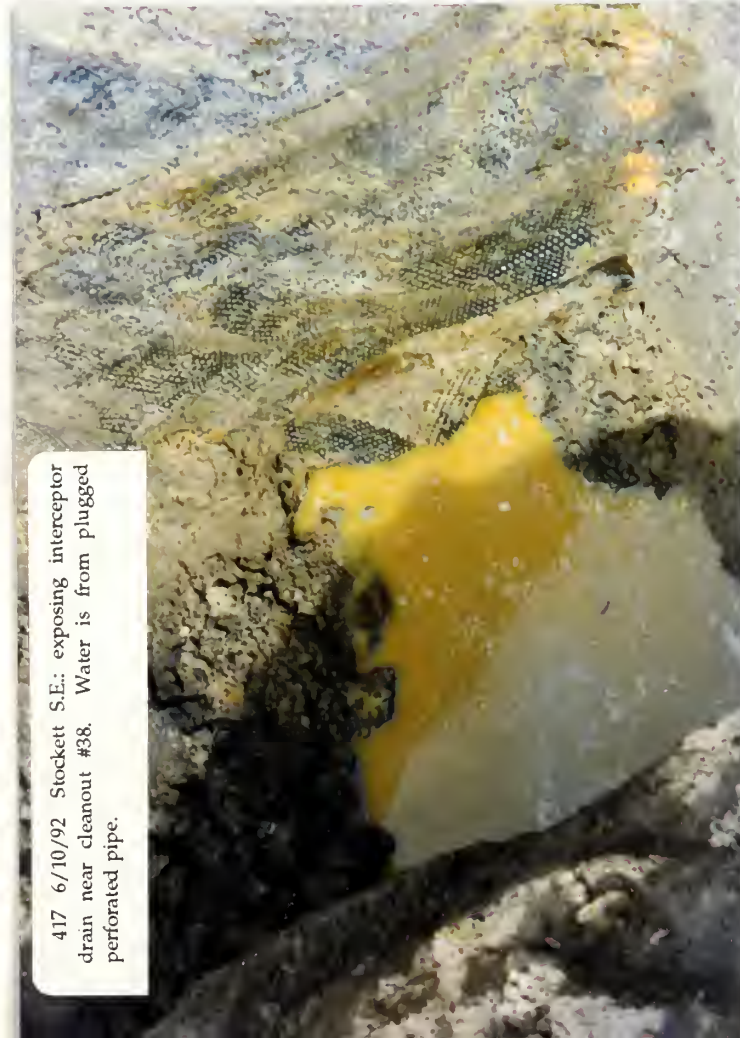
417 6/10/92 Stockett S.E.: exposing interceptor drain near cleanout #38. Water is from plugged perforated pipe.

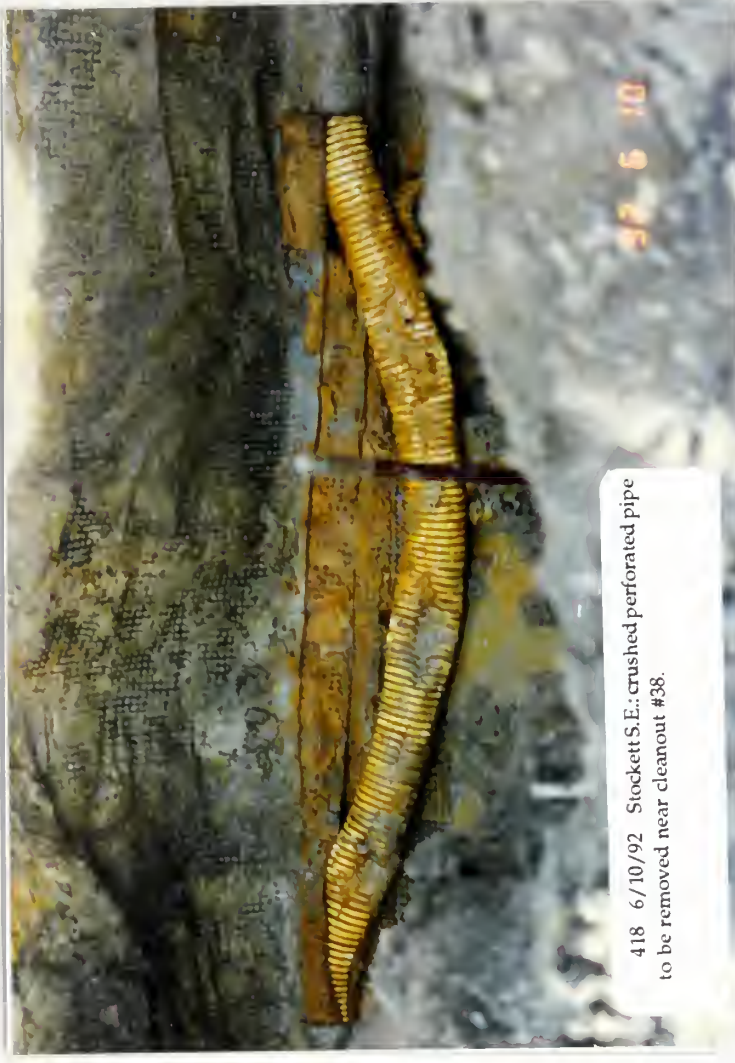
418 6/10/92 Stockett S.E.: crushed perforated pipe to be removed near cleanout #38.

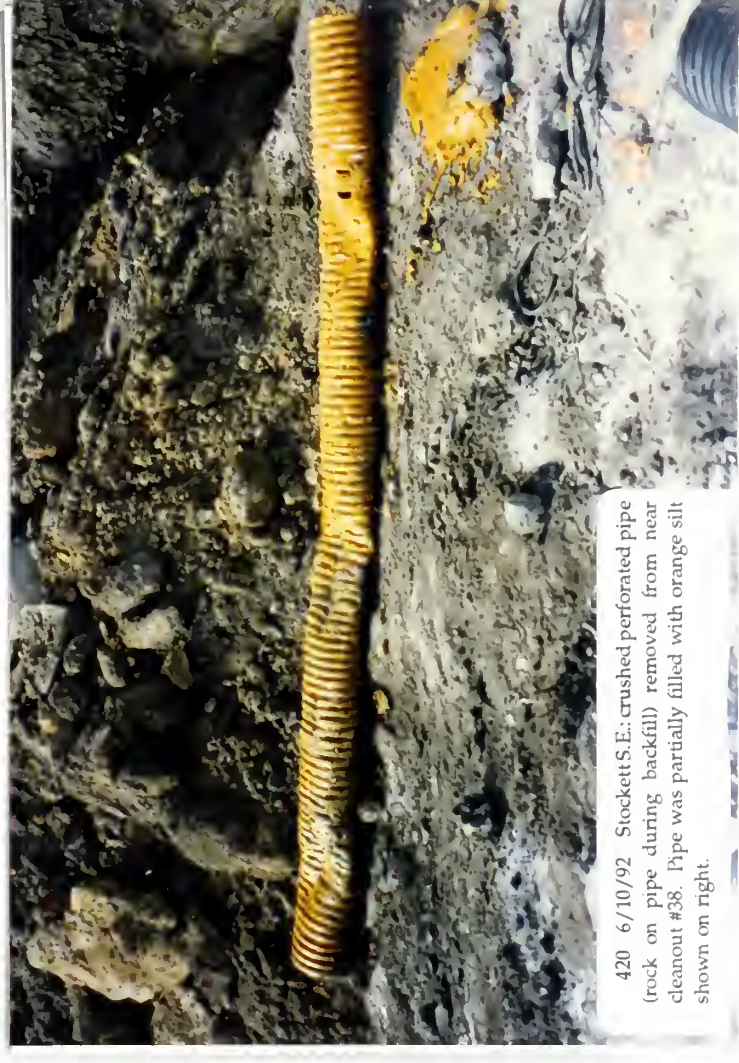
420 6/10/92 Stockett S.E.: crushed perforated pipe (rock on pipe during backfill) removed from near cleanout #38. Pipe was partially filled with orange silt shown on right.

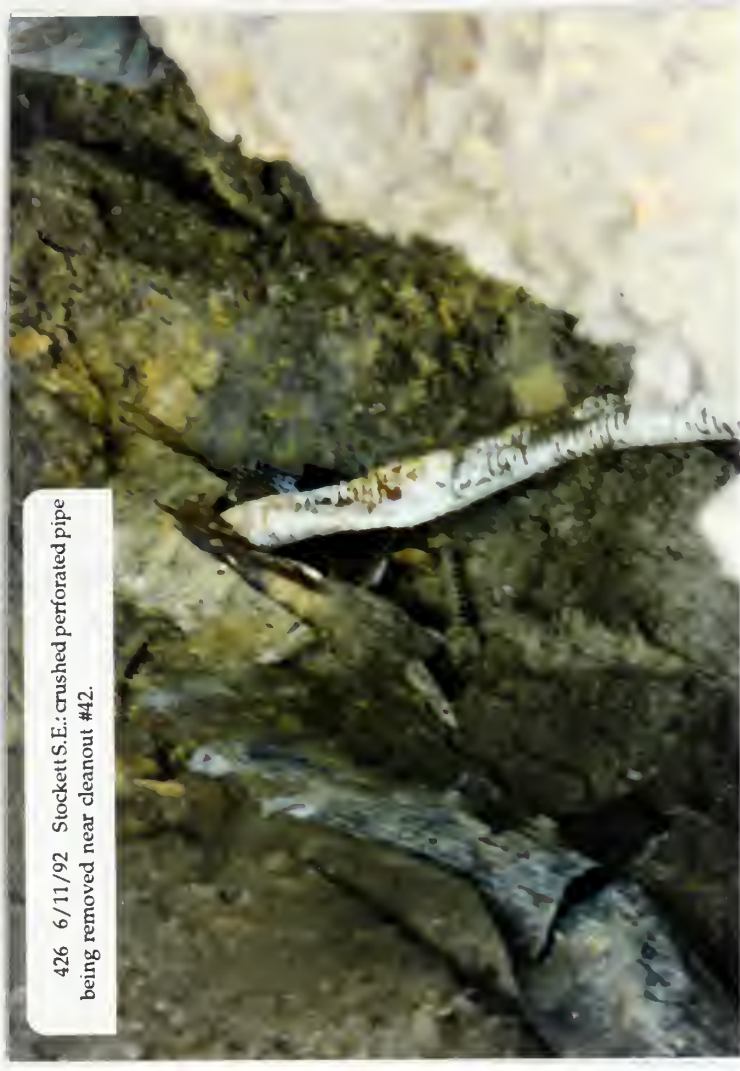
427 6/11/92 Stockett S.E.: crushed perforated pipe being removed near cleanout #42.

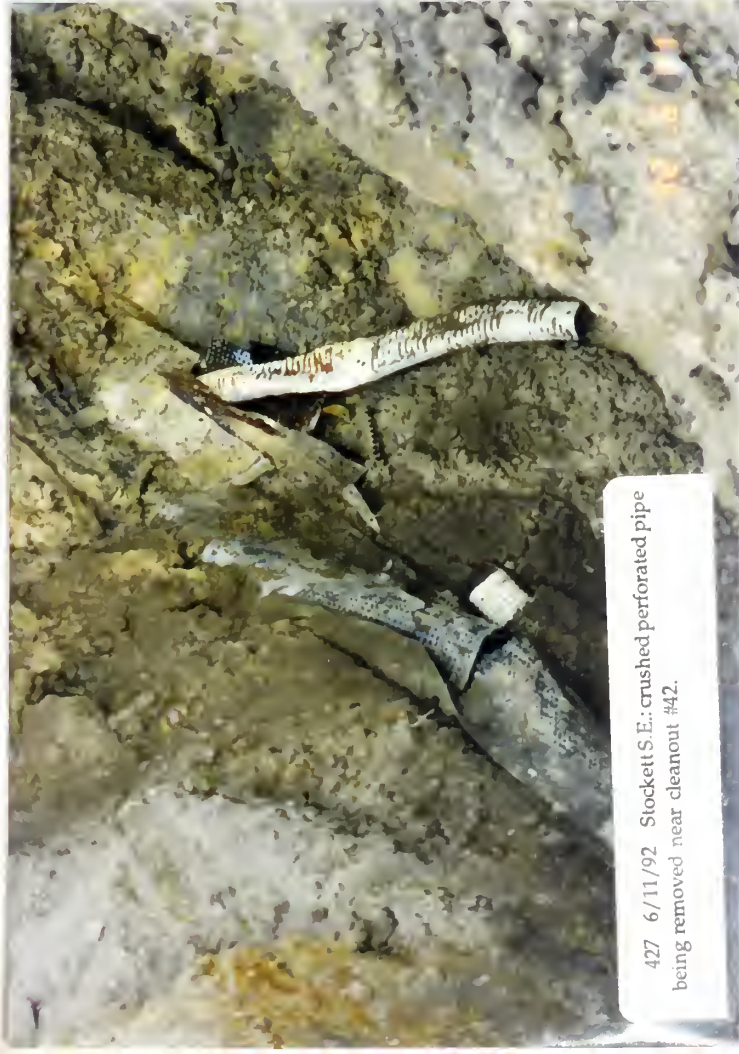
428 6/11/92 Stockett S.E.: close up of crushed perforated pipe removed near cleanout #42.

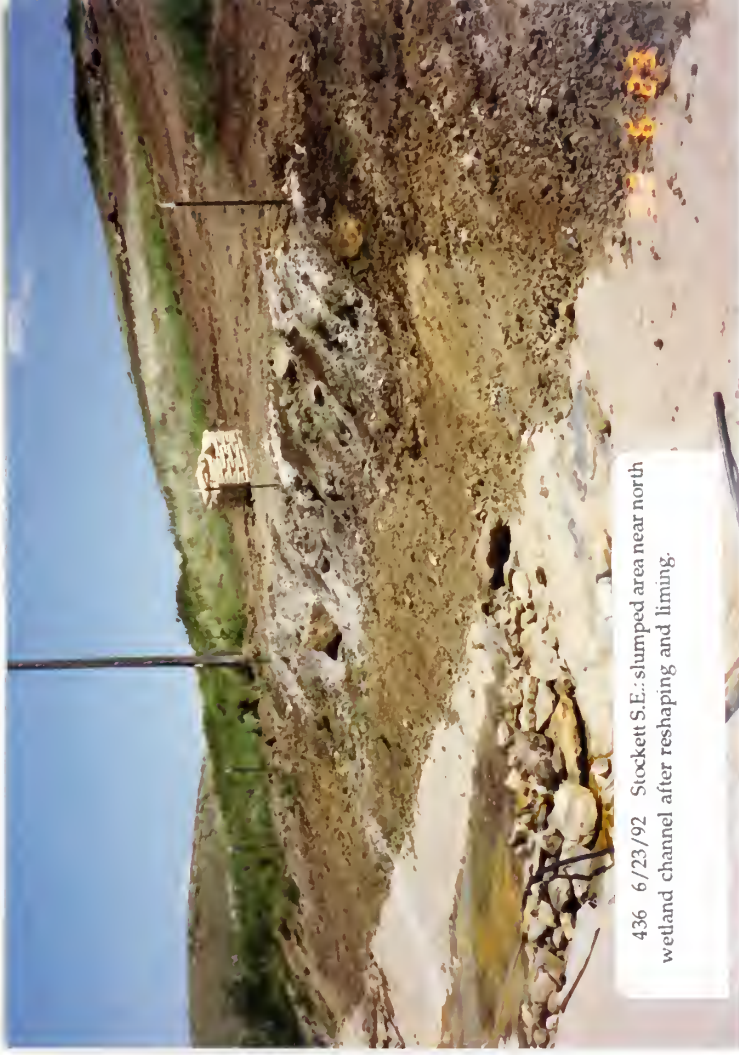
436 6/23/92 Stockett S.E.: slumped area near north wetland channel after reshaping and liming.

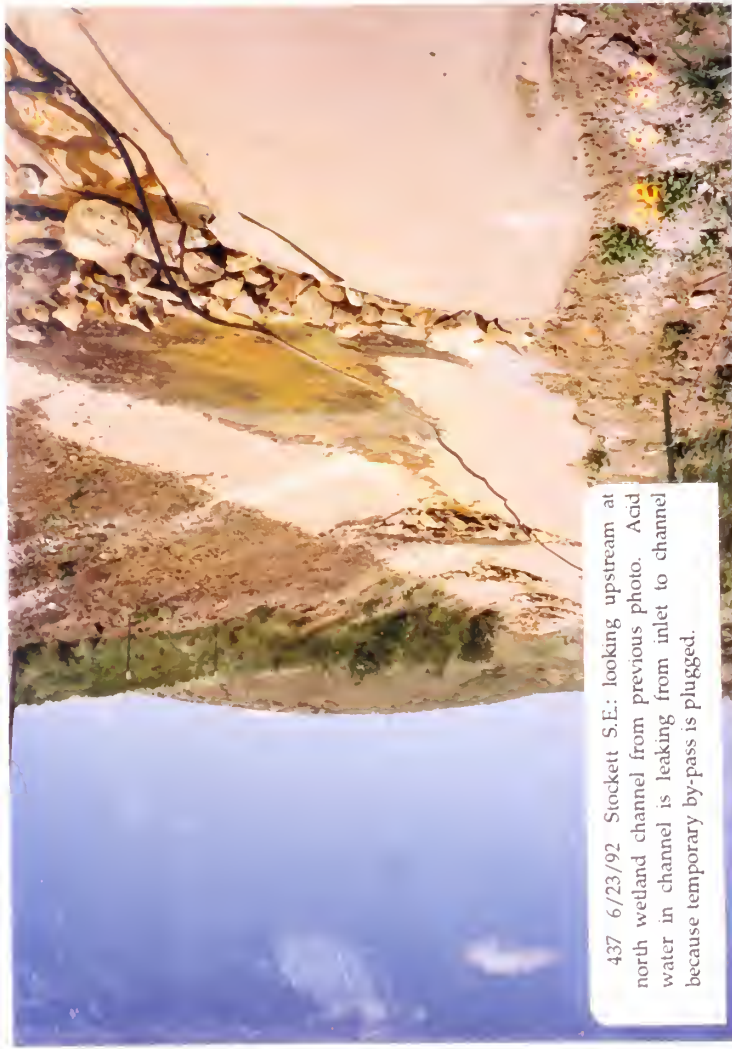
437 6/23/92 Stockett S.E.: looking upstream at north wetland channel from previous photo. Acid water in channel is leaking from inlet to channel because temporary by-pass is plugged.

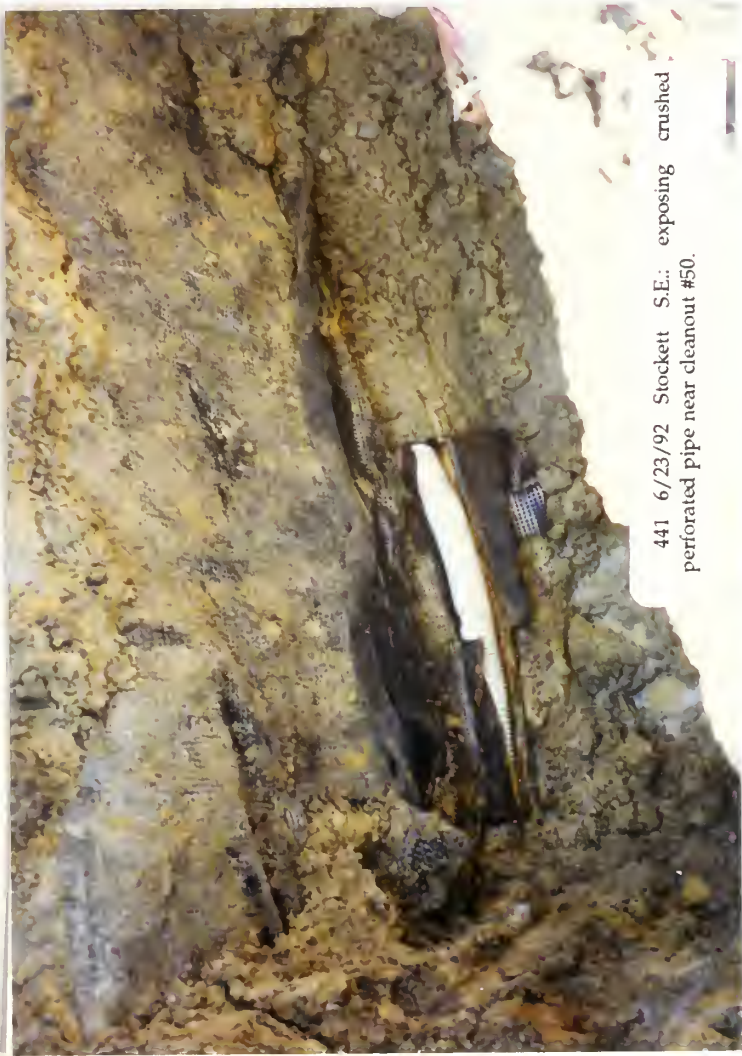
441 6/23/92 Stockett S.E.: exposing crushed perforated pipe near cleanout #50.

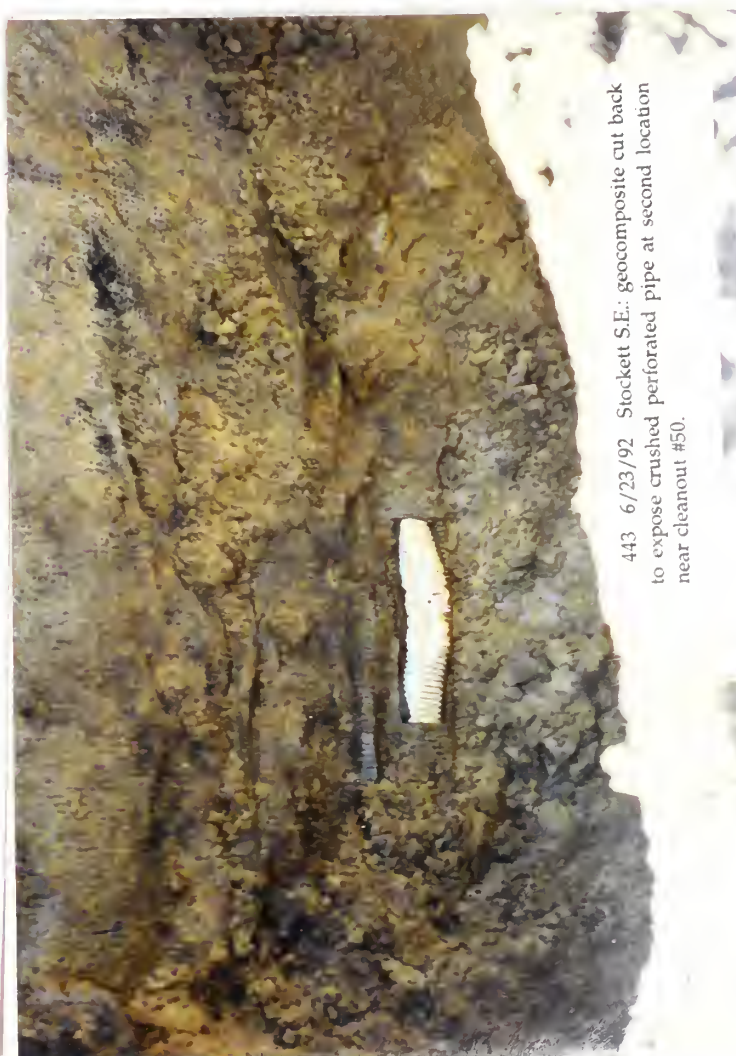
443 6/23/92 Stockett S.E.: geocomposite cut back to expose crushed perforated pipe at second location near cleanout #50.

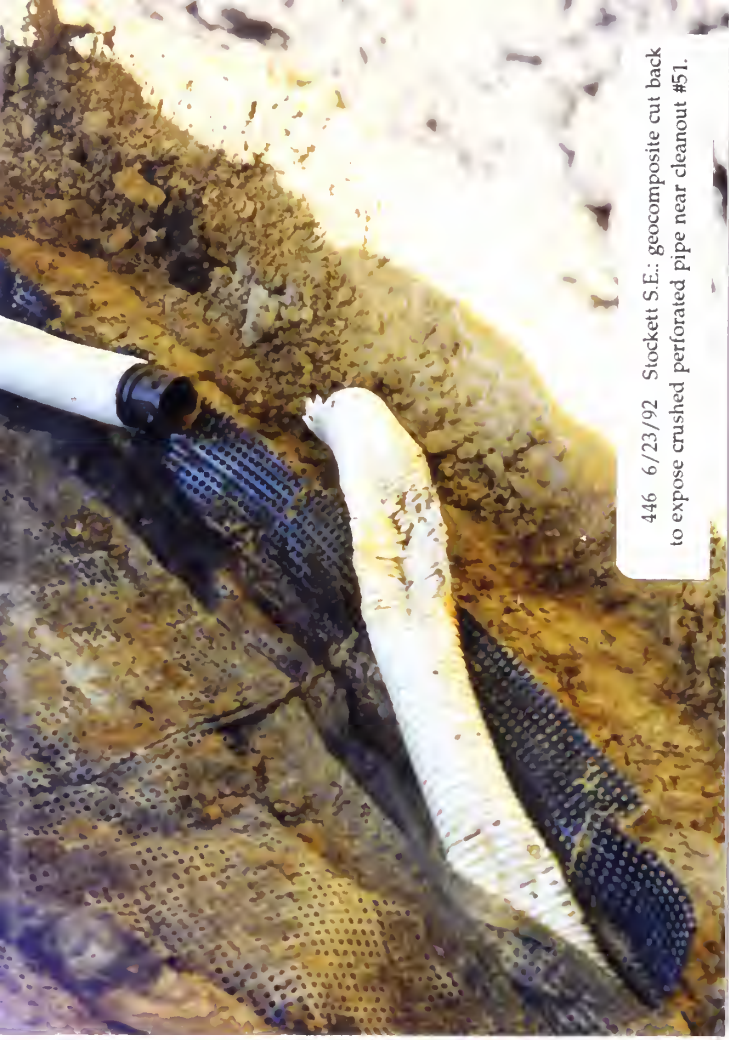
446 6/23/92 Stockett S.E.: geocomposite cut back to expose crushed perforated pipe near cleanout #51.

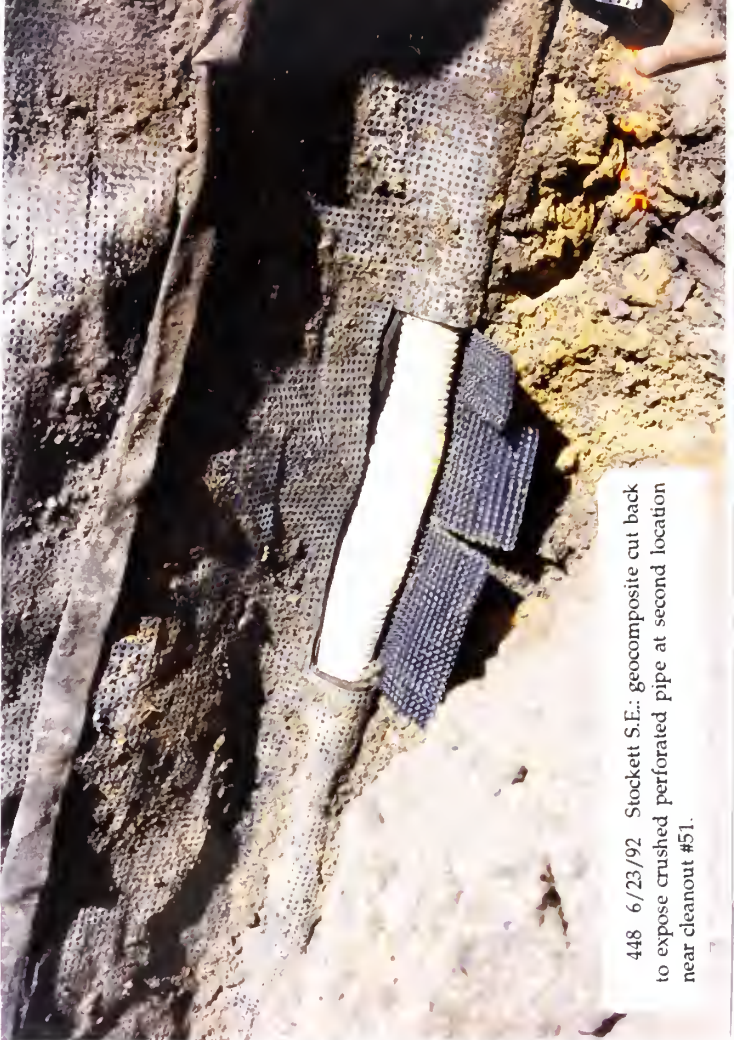
448 6/23/92 Stockett S.E.: geocomposite cut back to expose crushed perforated pipe at second location near cleanout #51.

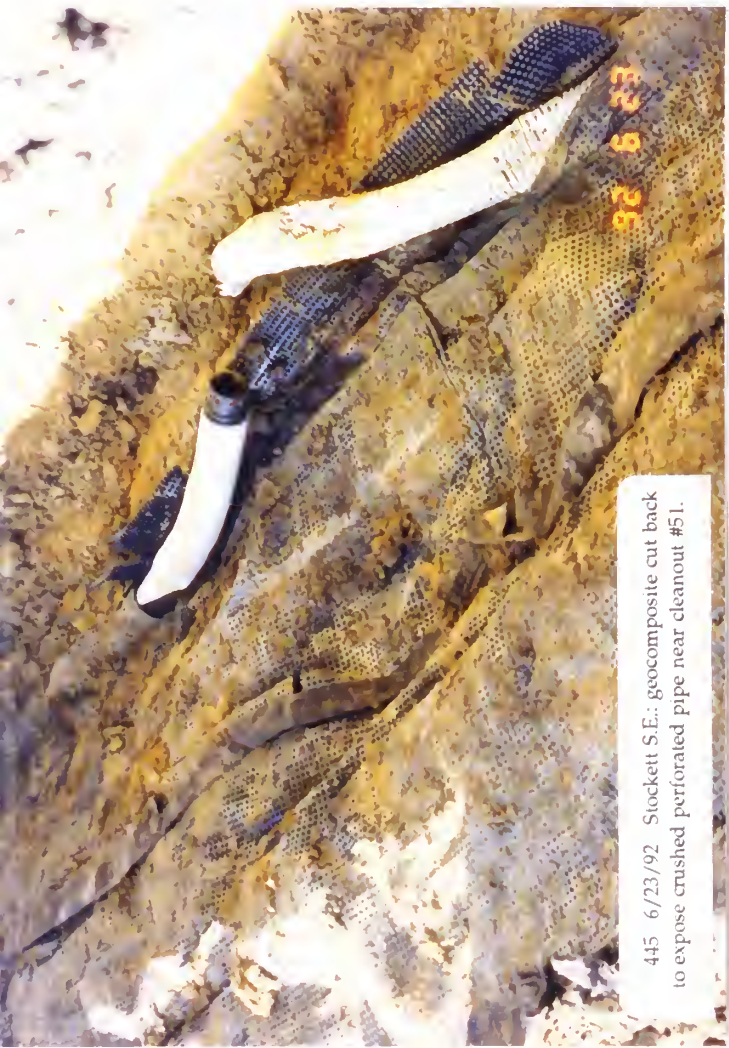
445 6/23/92 Stockett S.E.: geocomposite cut back to expose crushed perforated pipe near cleanout #51.

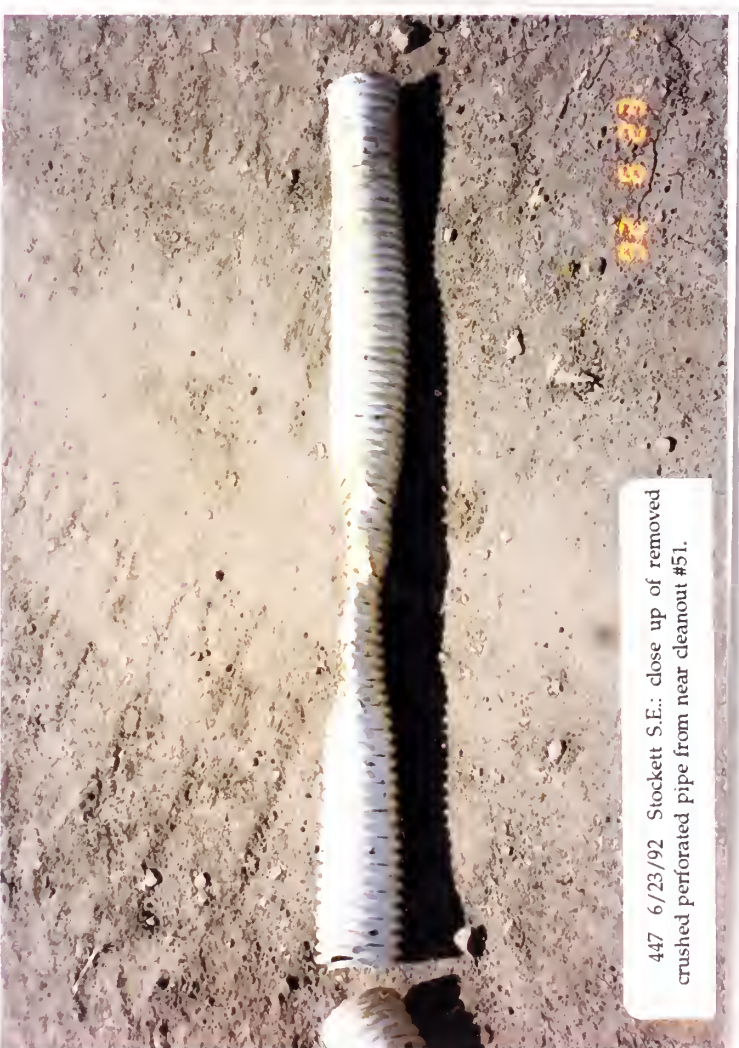
447 6/23/92 Stockett S.E.: close up of removed crushed perforated pipe from near cleanout #51.

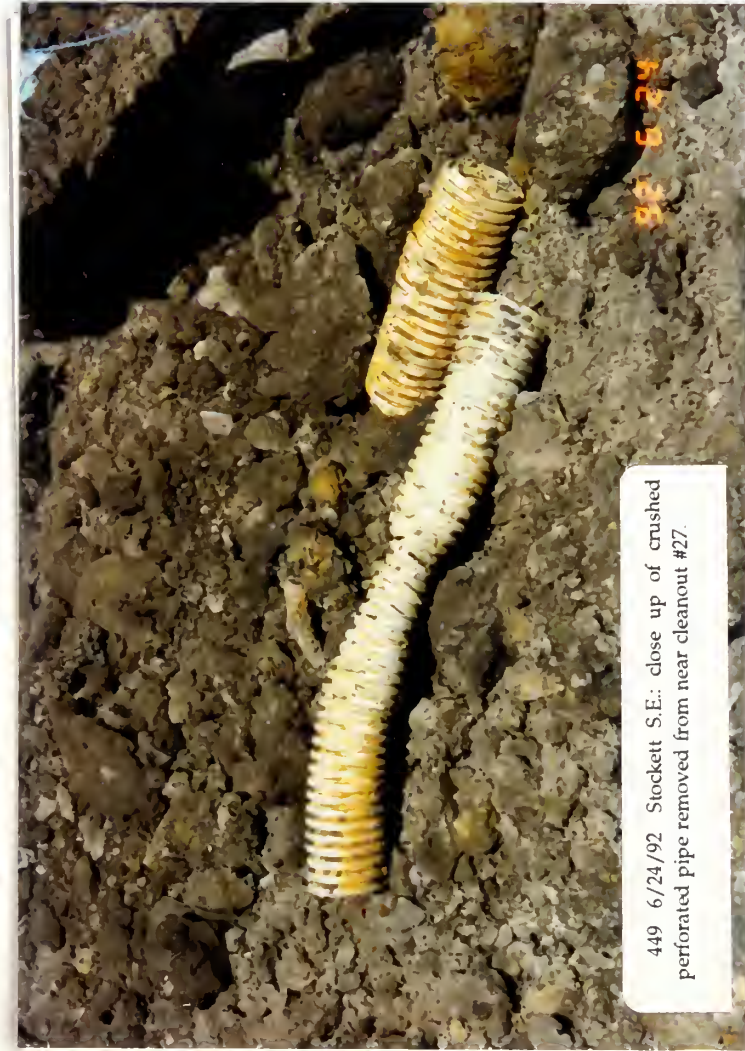
449 6/24/92 Stockett S.E.: close up of crushed perforated pipe removed from near cleanout #27.

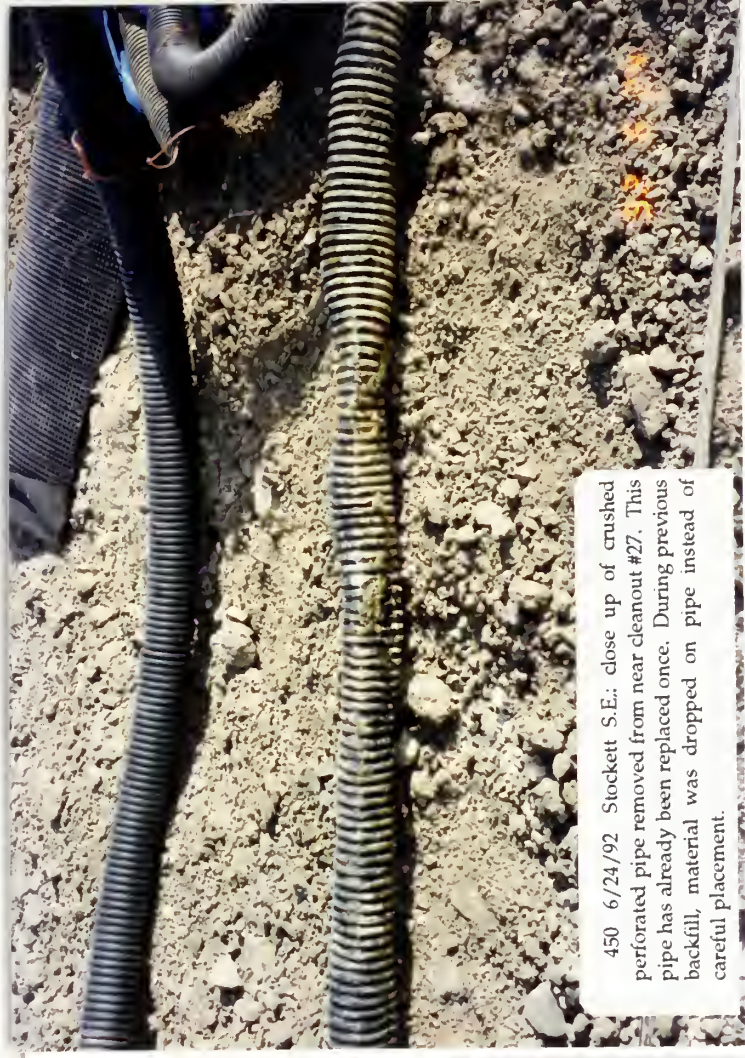
450 6/24/92 Stockett S.E.: close up of crushed perforated pipe removed from near cleanout #27. This pipe has already been replaced once. During previous backfill, material was dropped on pipe instead of careful placement.
